Subject: Adoption of Sewer at Hunters Mill in Downpatrick

Project Information

Project Name	Project Number	Project Date
DPH CONSTRUCTION HUNTERS MILL		27/05/2021

Section Inspection - 27/05/2021 - S1X

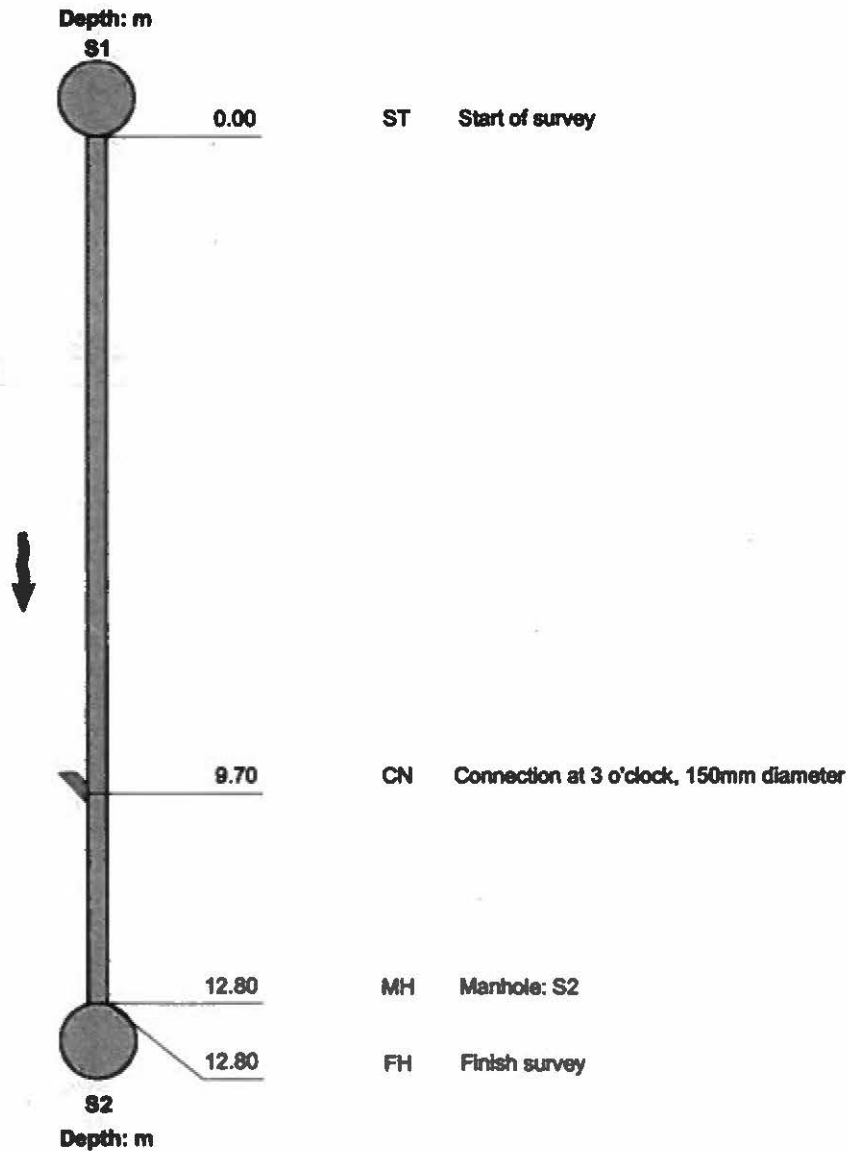
Structural Defects					Service & Operational Observations				
STR No. Def	STR Peak	STR Mean	STR Total	STR Grade	SER No. Def	SER Peak	SER Mean	SER Total	SER Grade
0	0.0	0.0	0.0	1.0	0	0.0	0.0	0.0	1.0

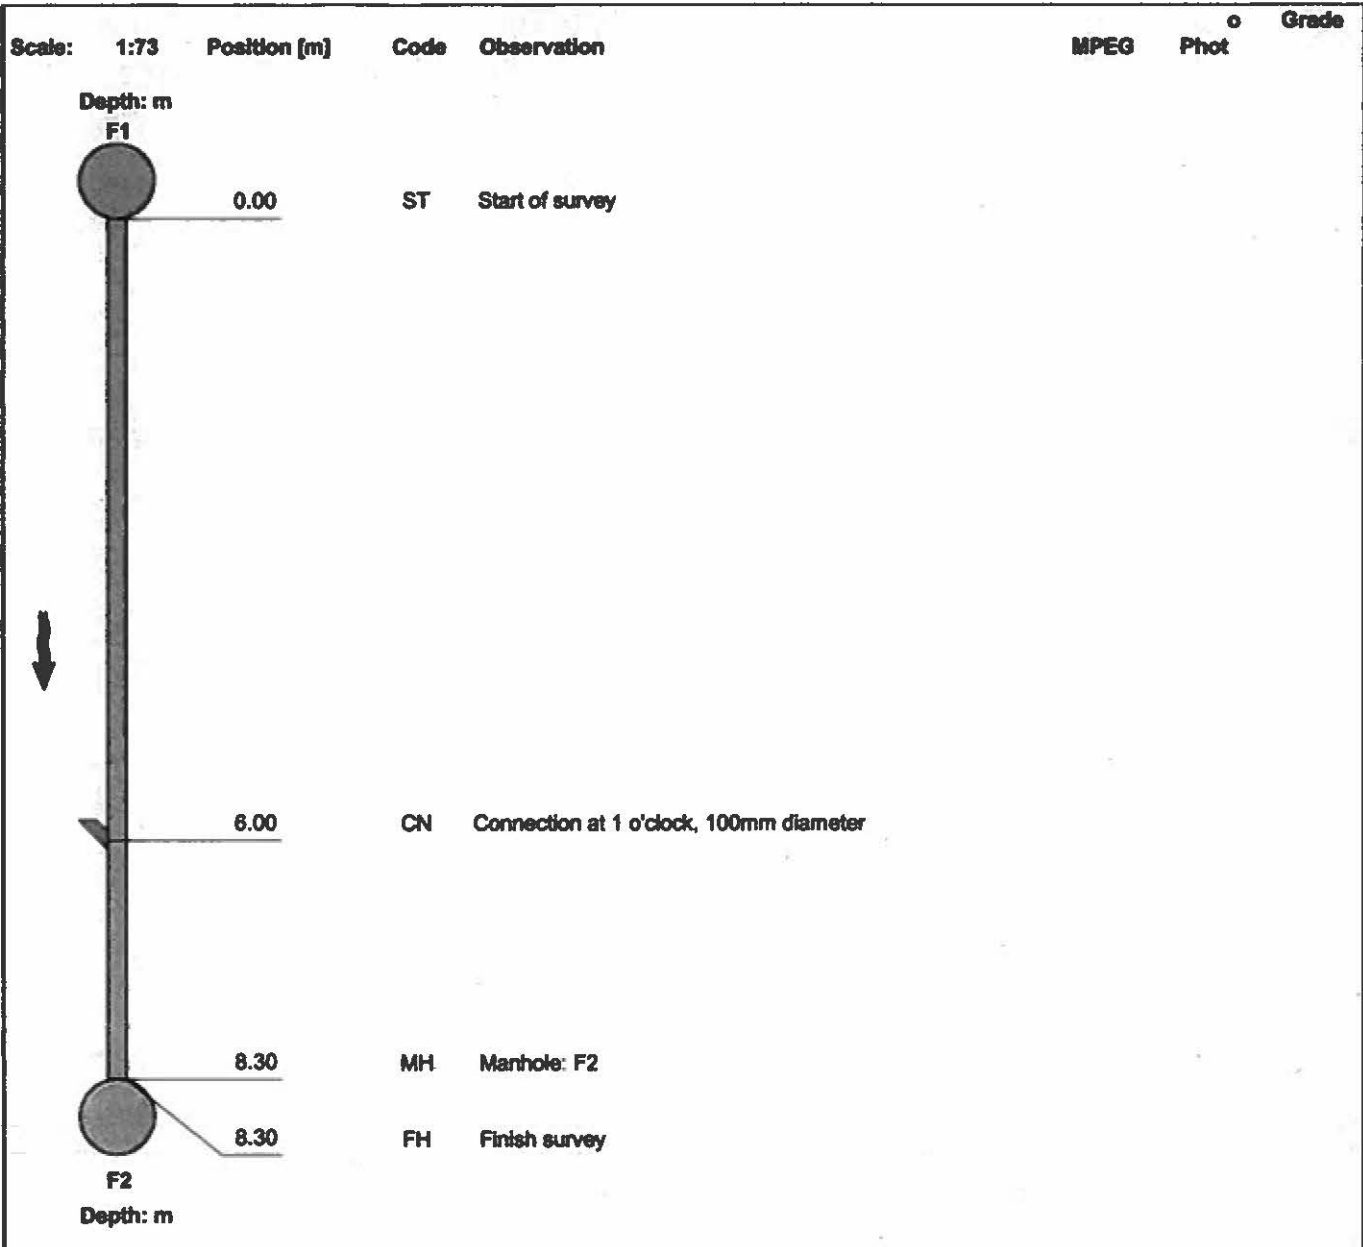
Section Inspection - 27/05/2021 - F1X

Construction Features					Miscellaneous Features				
Structural Defects					Service & Operational Observations				
STR No. Def	STR Peak	STR Mean	STR Total	STR Grade	SER No. Def	SER Peak	SER Mean	SER Total	SER Grade
0	0.0	0.0	0.0	1.0	0	0.0	0.0	0.0	1.0

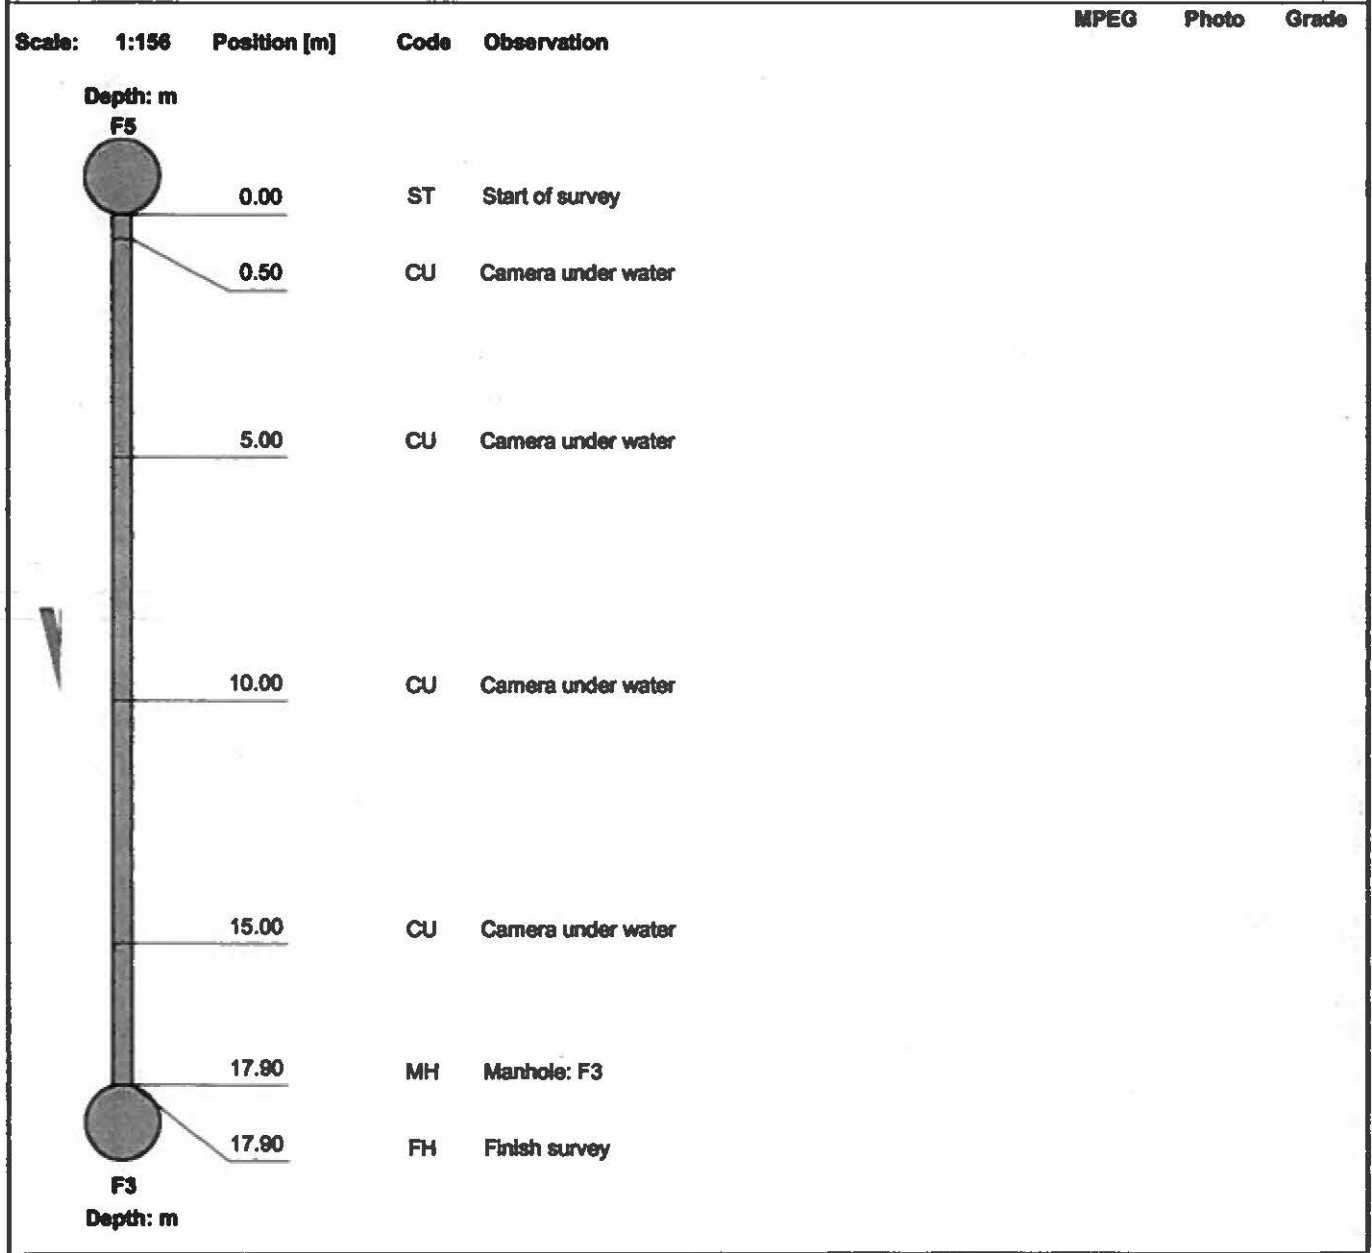
Section Inspection - 27/05/2021 - F5X

Construction Features					Miscellaneous Features				
Structural Defects					Service & Operational Observations				
STR No. Def	STR Peak	STR Mean	STR Total	STR Grade	SER No. Def	SER Peak	SER Mean	SER Total	SER Grade
0	0.0	0.0	0.0	1.0	0	0.0	0.0	0.0	1.0

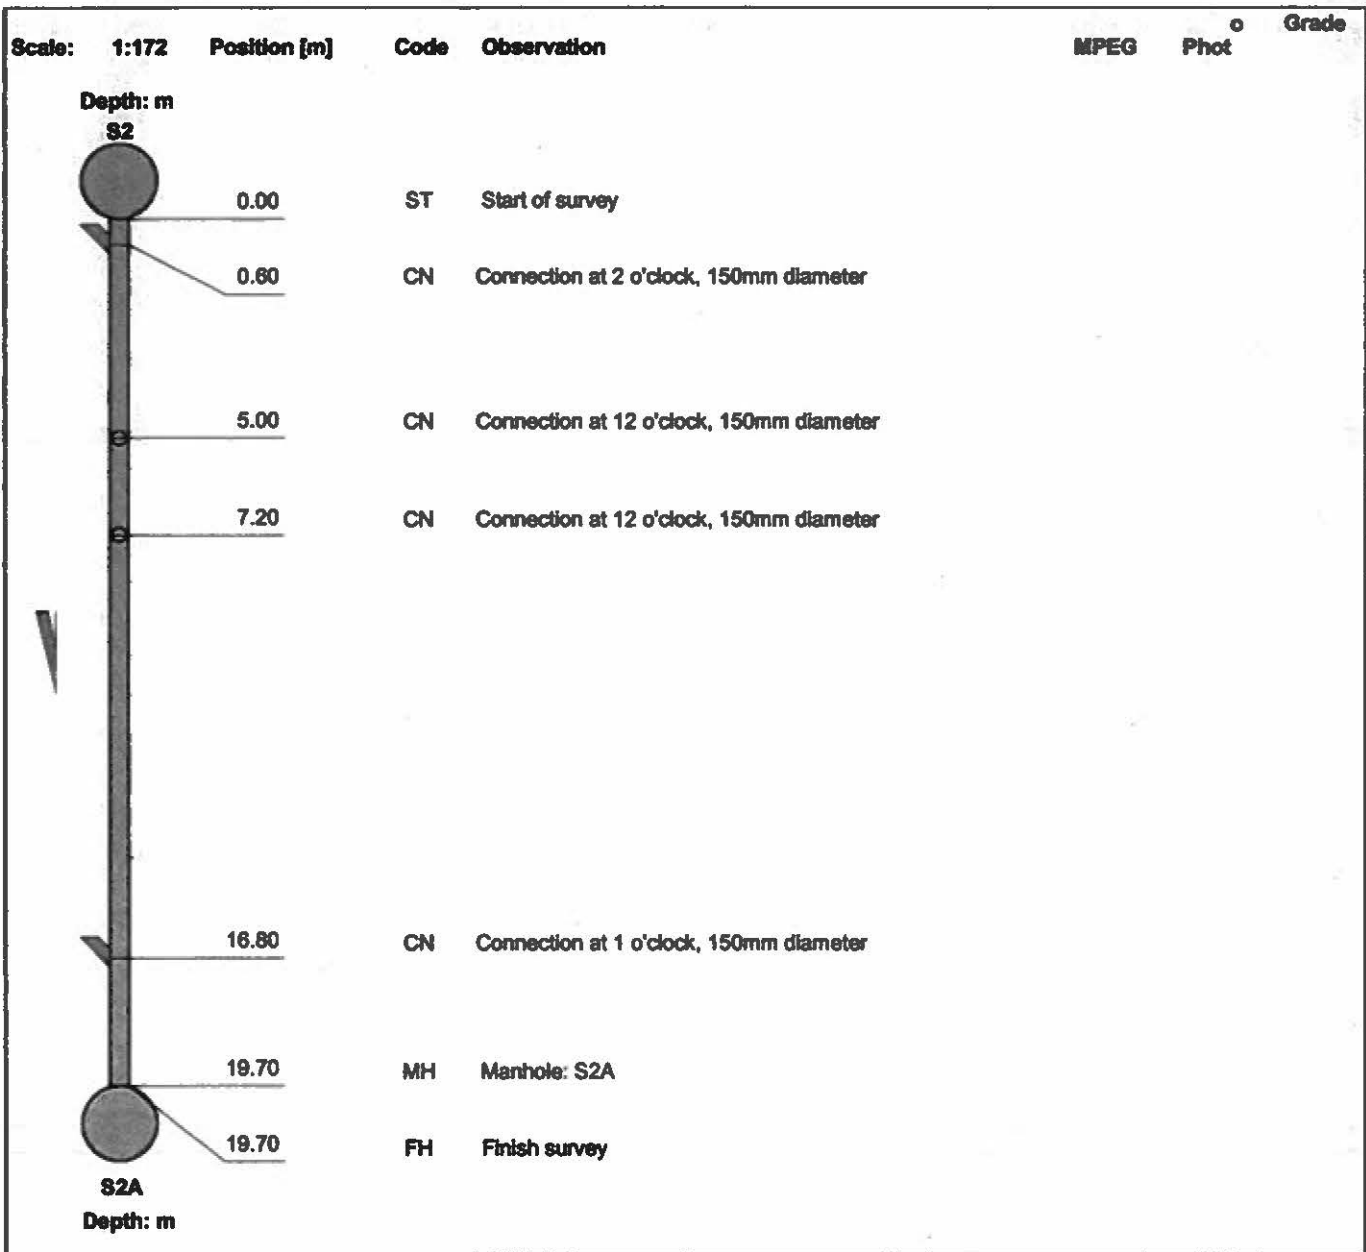
Section Inspection - 27/05/2021 - S2X

Construction Features					Miscellaneous Features				
Structural Defects					Service & Operational Observations				
STR No. Def	STR Peak	STR Mean	STR Total	STR Grade	SER No. Def	SER Peak	SER Mean	SER Total	SER Grade
0	0.0	0.0	0.0	1.0	0	0.0	0.0	0.0	1.0

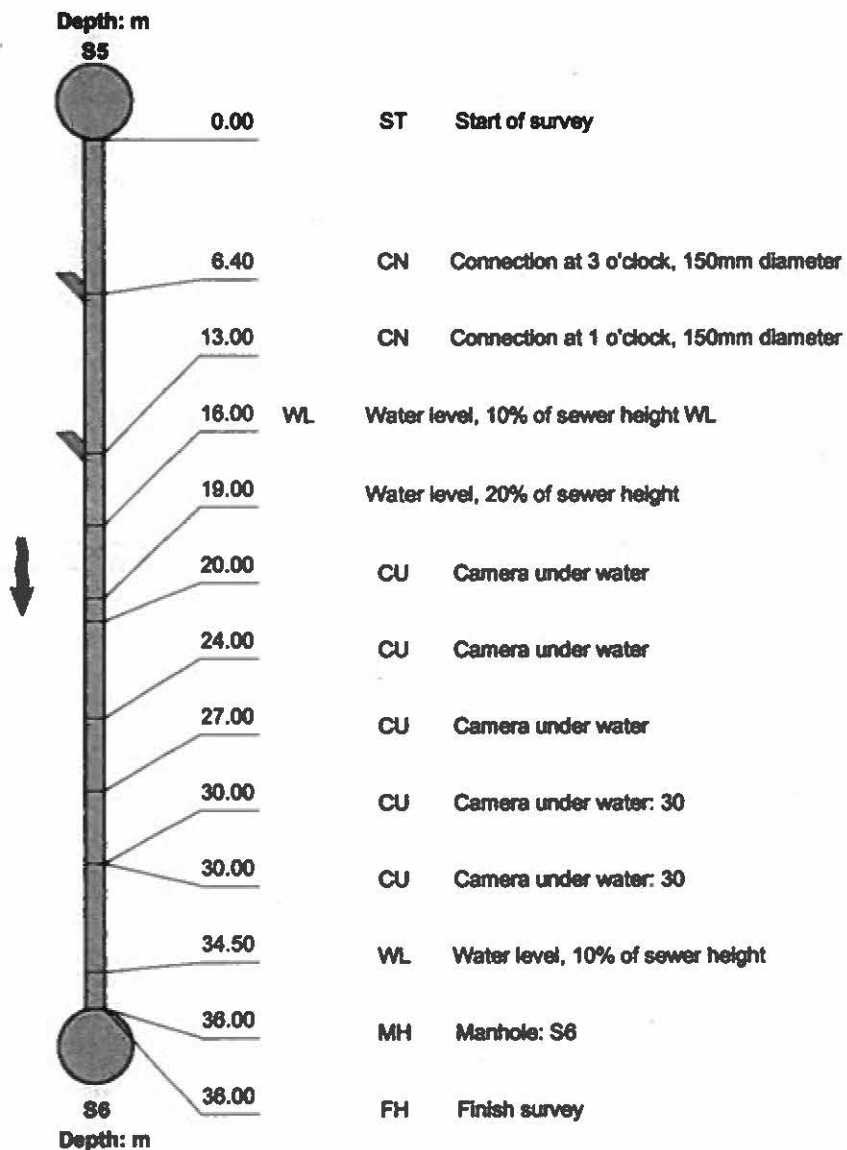
Section Inspection - 27/05/2021 - S5X

Construction Features					Miscellaneous Features				
Structural Defects					Service & Operational Observations				
STR No. Def	STR Peak	STR Mean	STR Total	STR Grade	SER No. Def	SER Peak	SER Mean	SER Total	SER Grade
0	0.0	0.0	0.0	1.0	0	0.0	0.0	0.0	1.0

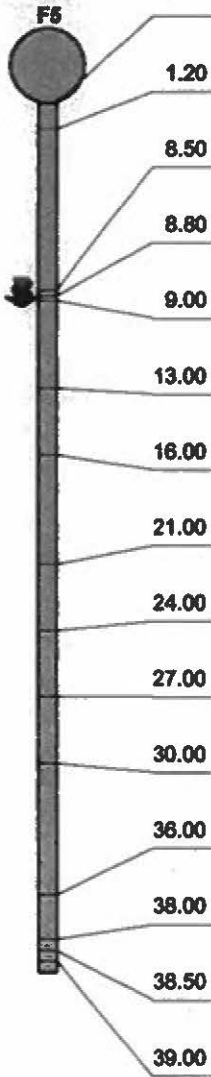
Section Inspection - 27/05/2021 - F5X

0.00	ST	Start of survey
1.20	OJM	Open joint, medium (between 1.0 and 1.5 times the pipe wall thickness)
8.50	WL	Water level, 20% of sewer height
8.80	CN	Connection at 2 o'clock, 100mm diameter
9.00	CU	Camera under water
13.00	CU	Camera under water
16.00	CU	Camera under water
21.00	CU	Camera under water
24.00	CU	Camera under water
27.00	CU	Camera under water
30.00	CU	Camera under water
36.00	CU	Camera under water
38.00	CU	Camera under water
38.50	WL	Water level, 10% of sewer height
39.00	D	Deformed sewer, 20% of original diameter/height

Construction Features					Miscellaneous Features				
Structural Defects					Service & Operational Observations				
STR No. Def	STR Peak	STR Mean	STR Total	STR Grade	SER No. Def	SER Peak	SER Mean	SER Total	SER Grade
2	40.0	1.0	41.0	3.0	0	0.0	0.0	0.0	1.0
